Manhole Inspection Report

Date:	05/08/2018	Weather:		Coding:	RZMACP
MH#:	M-1005-003	Owner:	NA	Len. Surveyed:	3.6
P.O.#:		Surveyor:	Jen Costello	Rim to Invert:	3.8
Customer:		Cert. #:	U-907-5518	Wall Material:	Concrete (reinforced)

Street:	685' South of Cleveland Ave. On Cou	Project:	Hobart, IN
City:	Hobart, IN	GPS Northing:	2915028.989
Location:		GPS Easting:	2915028.989
Drain Area:	Northeast	GPS Accuracy:	Sub-Meter
Cover Shape:	Circular	Evidence of Surcharge:	No
Cover Size:	22.5	Potential for Runoff:	None
Comments:

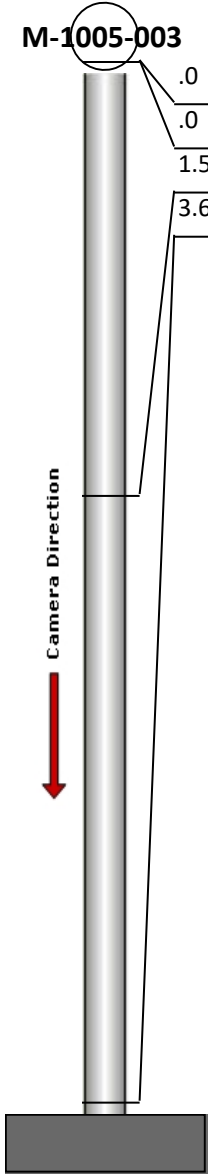
.0	MGP	General Photo	10	NA
	.0	DAE	Deposits Attached Encrustation	21	M 2
	1.5	MGO	General Observation	37	NA
	3.6	MGO	General Observation	55	NA
