Manhole Inspection Report

| MH#: | M-1006-002 | Owner: | NA | Len. Surveyed: | 16.1 |

| Street: | North of 10th St. 354' West of Vermi | Project: | Hobart, IN |

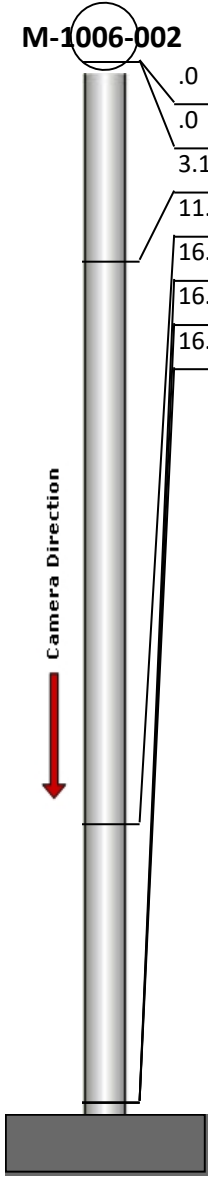
| | Position | Code | Observation | Video (sec) | Grade |
|--|---|---|---|---|---|
| | .0 | MGO | General Observation | 10 | NA |
| | .0 | SRI | Surface Roughness Increased | 21 | S 1 |
| | 3.1 | MGO | General Observation | 41 | NA |
| | 11.8 | IW | Infil Weeper | 72 | M 2 |
| | 16.1 | DSF | Deposits Settled Fine | 93 | M 2 |
| | 16.1 | SRI | Surface Roughness Increased | 104 | S 1 |
| | 16.1 | MGO | General Observation | 115 | NA |
