Manhole Inspection Report

Date:	04/22/2018	Weather:		Coding:	RZMACP
MH#:	M-1006-006	Owner:	NA	Len. Surveyed:	6.9
P.O.#:		Surveyor:	John Kuglmaier	Rim to Invert:	7.1
Customer:	8.7	Cert. #:	U-1215-07002349	Wall Material:	Concrete (reinforced)

Street:	Intersection of Vermillion St. and 9t	Project:	Hobart, IN
City:	Hobart, IN	GPS Northing:	0.0
Location:		GPS Easting:	0.0
Drain Area:	Southeast	GPS Accuracy:	Nearest Meter
Cover Shape:	Circular	Evidence of Surcharge:	No
Cover Size:	22.5	Potential for Runoff:	None
Comments:

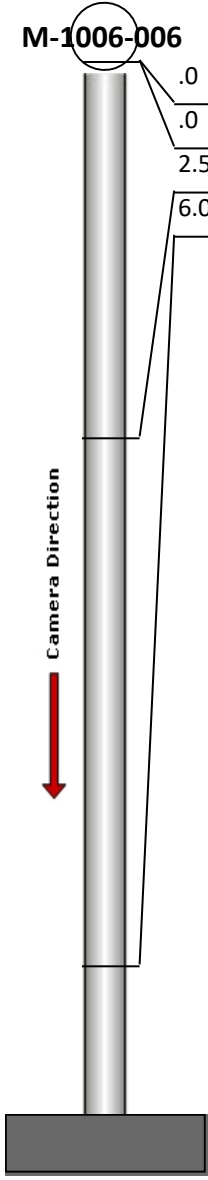
.0	MGP	General Photo	10	NA
	.0	RFJ	Roots Fine Joint	22	M 1
	2.5	MGP	General Photo	41	NA
	6.0	MGO	General Observation	62	NA
