Manhole Inspection Report

| MH#: | M-1006-011 | Owner: | NA | Len. Surveyed: | 9.8 |

| Street: | N of Hwy 130. 1373' East of Sullivan | Project: | Hobart, IN |

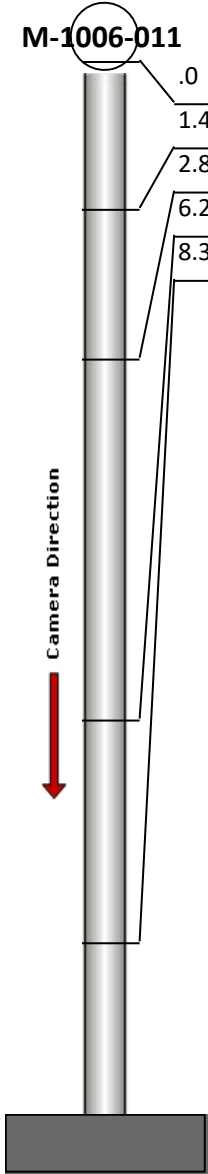
| | Position | Code | Observation | Video (sec) | Grade |
|--|---|---|---|---|---|
| | .0 | MGP | General Photo | 10 | NA |
| | 1.4 | IS | Infil Stain | 24 | NA |
| | 2.8 | MGP | General Photo | 41 | NA |
| | 6.2 | DSF | Deposits Settled Fine | 62 | M 2 |
| | 8.3 | MGO | General Observation | 77 | NA |
