Manhole Inspection Report

Date:	04/18/2018	Weather:		Coding:	RZMACP
MH#:	M-103-006	Owner:	NA	Len. Surveyed:	8.8
P.O.#:		Surveyor:	Jen Costello	Rim to Invert:	10.4
Customer:		Cert. #:	U-907-5518	Wall Material:	Concrete (reinforced)

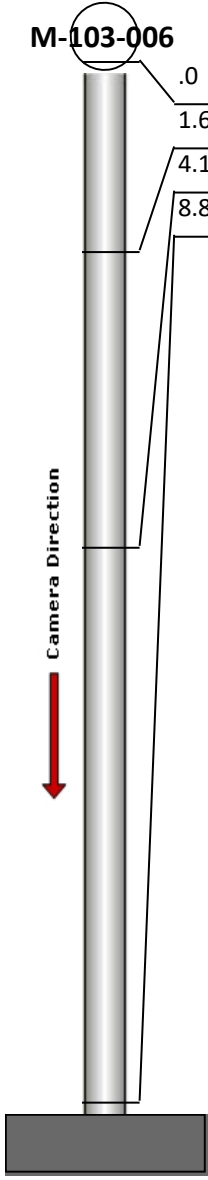
M-103-006				
	.0	MGO	General Observation	10	NA
	1.6	MGP	General Photo	26	NA
	4.1	IW	Infil Weeper	44	M 2
	8.8	OBZ	Obstacle Other	65	M 2
