Manhole Inspection Report

Date:	04/18/2018	Weather:		Coding:	RZMACP
MH#:	M-103-020	Owner:	NA	Len. Surveyed:	11.4
P.O.#:		Surveyor:	John Kuglmaier	Rim to Invert:	13.9
Customer:		Cert. #:	U-1215-07002349	Wall Material:	Concrete (reinforced)

Street:	Missouri St. 257' South of 40th Ave.	Project:	Hobart, IN
City:	Hobart, IN	GPS Northing:	2890107.746
Location:		GPS Easting:	2890107.746
Drain Area:	Northwest	GPS Accuracy:	Sub-Meter
Cover Shape:	Circular	Evidence of Surcharge:	No
Cover Size:	23.0	Potential for Runoff:	None
Comments:

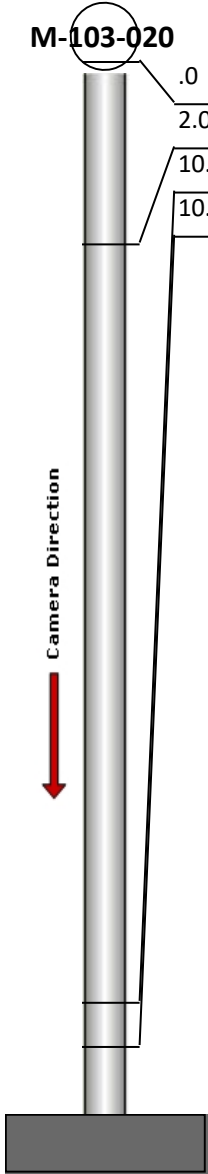
Position	Code	Observation	Video (sec)	Grade

.0	MGP	General Photo	10	NA
	2.0	MGP	General Photo	28	NA
	10.3	DSF	Deposits Settled Fine	58	M 2
	10.8	MGO	General Observation	70	NA
