Manhole Inspection Report

Date:	04/18/2018	Weather:		Coding:	RZMACP
MH#:	M-103-021	Owner:	NA	Len. Surveyed:	11.4
P.O.#:		Surveyor:	John Kuglmaier	Rim to Invert:	13.3
Customer:		Cert. #:	U-1215-07002349	Wall Material:	Concrete (reinforced)

Street:	Missouri St. 40' North of 40th Ave.	Project:	Hobart, IN
City:	Hobart, IN	GPS Northing:	2890101.104
Location:		GPS Easting:	2890101.104
Drain Area:	Northwest	GPS Accuracy:	Sub-Meter
Cover Shape:	Circular	Evidence of Surcharge:	Yes
Cover Size:	23.0	Potential for Runoff:	None
Comments:

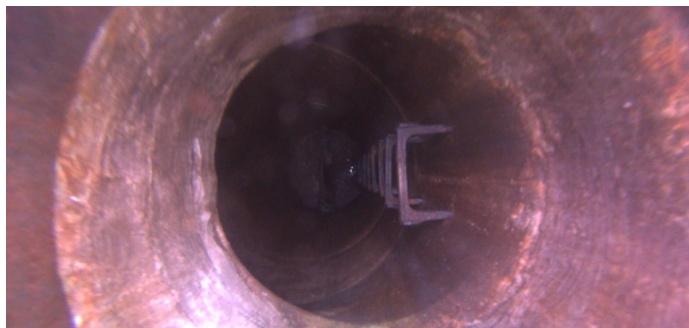
Code: **MGP**
Description: **General Photo**

Distance (ft): **.0**
Structural Grade: **0**
O&M Grade: **0**
Clock Start/From:
Clock To:
1st Value:
2nd Value:
Value Percent:
Step: **NO**
Remarks:

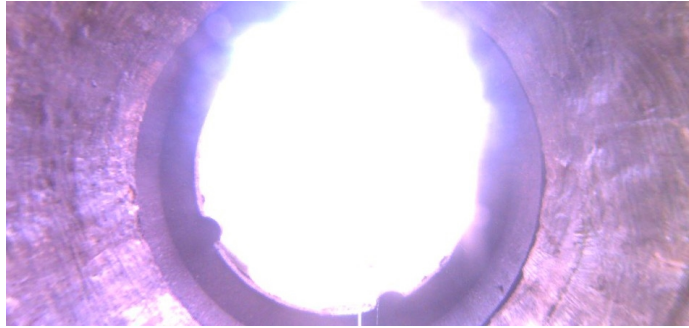
Code: **MGP**
Description: **General Photo**

Distance (ft): **2.2**
Structural Grade: **0**
O&M Grade: **0**
Clock Start/From:
Clock To:
1st Value:
2nd Value:
Value Percent:
Step: **NO**
Remarks:
