Manhole Inspection Report

Date:	04/18/2018	Weather:		Coding:	RZMACP
MH#:	M-103-022	Owner:	NA	Len. Surveyed:	12.1
P.O.#:		Surveyor:	John Kuglmaier	Rim to Invert:	13.0
Customer:		Cert. #:	U-1215-07002349	Wall Material:	Concrete (reinforced)

Street:	Missouri St. 350' South of 39th Ave.	Project:	Hobart, IN
City:	Hobart, IN	GPS Northing:	2890095.135
Location:		GPS Easting:	2890095.135
Drain Area:	Northwest	GPS Accuracy:	Sub-Meter
Cover Shape:	Circular	Evidence of Surcharge:	No
Cover Size:	23.0	Potential for Runoff:	None
Comments:

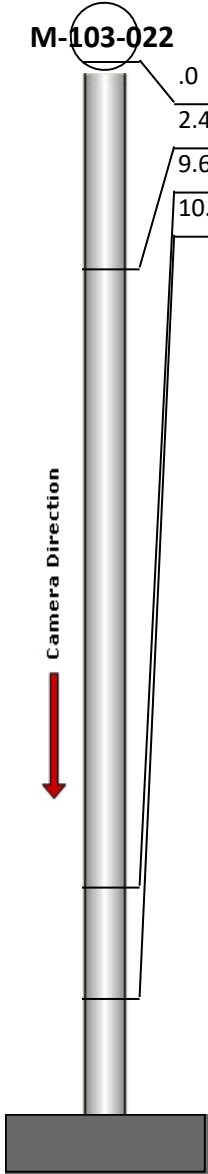
0.0	MGP	General Photo	10	NA
	2.4	MGP	General Photo	29	NA
	9.6	DAZ	Deposits Attached Other	57	M 2
	10.9	MGO	General Observation	71	NA
