Manhole Inspection Report

Date:	04/18/2018	Weather:		Coding:	RZMACP
MH#:	M-103-025	Owner:	NA	Len. Surveyed:	8.2
P.O.#:		Surveyor:	John Kuglmaier	Rim to Invert:	9.4
Customer:		Cert. #:	U-1215-07002349	Wall Material:	Concrete (reinforced)

Street:	Missouri St. 174' West of Willow St.	Project:	Hobart, IN
City:	Hobart, IN	GPS Northing:	2890590.341
Location:		GPS Easting:	2890590.341
Drain Area:	Northwest	GPS Accuracy:	Sub-Meter
Cover Shape:	Circular	Evidence of Surcharge:	No
Cover Size:	23.0	Potential for Runoff:	None
Comments:

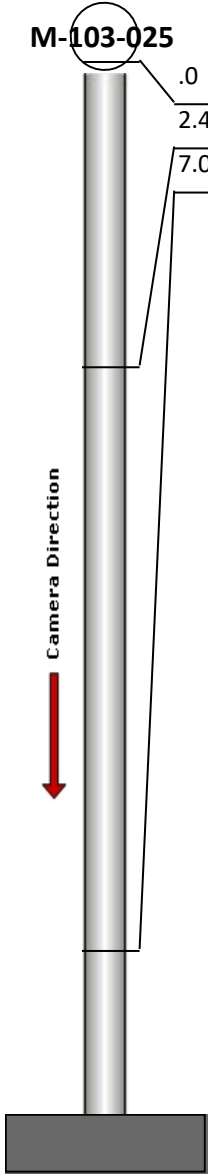
Position	Code	Observation	Video (sec)	Grade

.0	MGP	General Photo	10	NA
	2.4	MGP	General Photo	29	NA
	7.0	MGO	General Observation	52	NA
