Manhole Inspection Report

Date:	04/18/2018	Weather:		Coding:	RZMACP
MH#:	M-103-026	Owner:	NA	Len. Surveyed:	6.6
P.O.#:		Surveyor:	John Kuglmaier	Rim to Invert:	8.9
Customer:		Cert. #:	U-1215-07002349	Wall Material:	Concrete (reinforced)

Street:	Intersection of 39th Ave. and Willow	Project:	Hobart, IN
City:	Hobart, IN	GPS Northing:	2890763.045
Location:		GPS Easting:	2890763.045
Drain Area:	Northwest	GPS Accuracy:	Sub-Meter
Cover Shape:	Circular	Evidence of Surcharge:	Yes
Cover Size:	23.0	Potential for Runoff:	None
Comments:

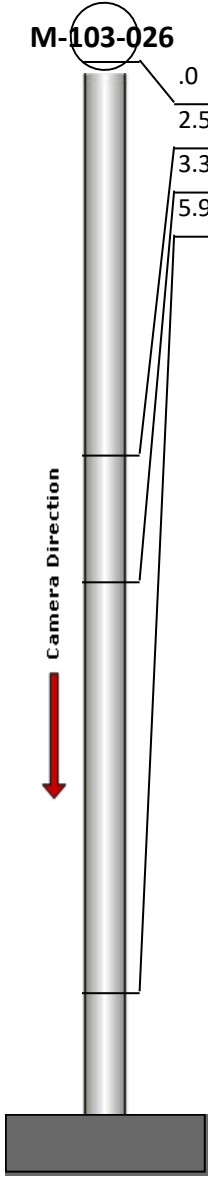
.0	MGP	General Photo	10	NA
	2.5	MGP	General Photo	29	NA
	3.3	IS	Infil Stain	44	NA
	5.9	DAZ	Deposits Attached Other	61	M 2
