# Manhole Inspection Report

Date:	10/04/2022	Weather:		Coding:	RZMACP
MH#:	M-103-030	Owner:	NA	Len. Surveyed:	12.9
P.O.#:		Surveyor:	Jen Costello	Rim to Invert:	14.0
Customer:		Cert. #:	U-907-5518	Wall Material:	Concrete (reinforced)

Street:	Alley Howard St. and Colborne St. 2	Project:	Missing GPS
City:	Hobart, IN	GPS Northing:	0.0
Location:		GPS Easting:	0.0
Drain Area:	Northwest	GPS Accuracy:	
Cover Shape:	Circular	Evidence of Surcharge:	
Cover Size:	24.0	Potential for Runoff:	
Comments:

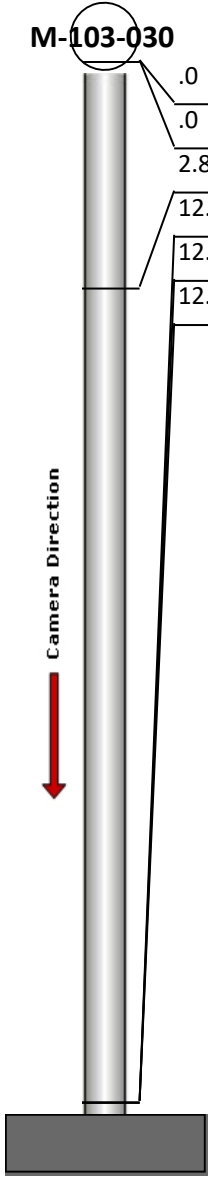
M-103-030				
	.0	MGO	General Observation	10	NA
	.0	SAV	Surface Aggregate Visible	21	S 3
	2.8	MGO	General Observation	40	NA
	12.9	DSGV	Deposits Settled Gravel	75	M 2
	12.9	SAV	Surface Aggregate Visible	86	S 3
	12.9	MGO	General Observation	97	NA
