Manhole Inspection Report

Date:	04/18/2018	Weather:		Coding:	RZMACP
MH#:	M-103-101	Owner:	NA	Len. Surveyed:	4.2
P.O.#:		Surveyor:	John Kuglmaier	Rim to Invert:	7.0
Customer:		Cert. #:	U-1215-07002349	Wall Material:	Concrete (reinforced)

Street:	Maple St. 575' South of 39th Ave.	Project:	Hobart, IN
City:	Hobart, IN	GPS Northing:	2889769.466
Location:		GPS Easting:	2889769.466
Drain Area:	Northwest	GPS Accuracy:	Sub-Meter
Cover Shape:	Circular	Evidence of Surcharge:	No
Cover Size:	23.0	Potential for Runoff:	None
Comments:

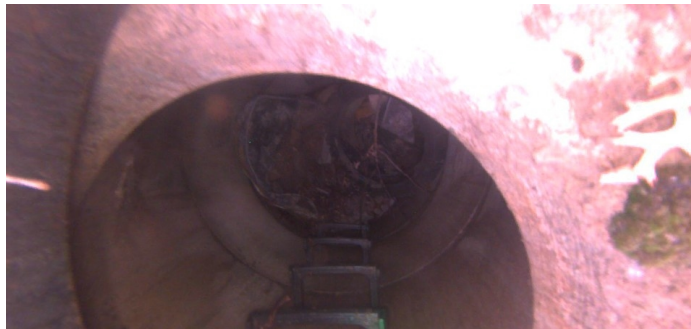
Code: **MGP**
Description: **General Photo**

Distance (ft): **.0**
Structural Grade: **0**
O&M Grade: **0**
Clock Start/From:
Clock To:
1st Value:
2nd Value:
Value Percent:
Step: **NO**
Remarks:

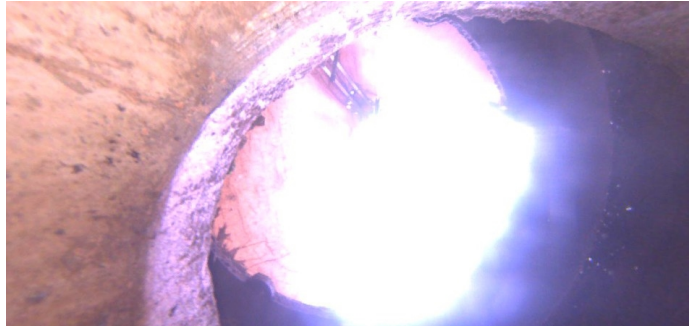
Code:	MGP
Description:	General Photo
Distance (ft):	1.7
Structural Grade:	0
O&M Grade:	0
Clock Start/From:	
Clock To:	
1st Value:	
2nd Value:	
Value Percent:	
Step:	NO
Remarks:
