Manhole Inspection Report

Date:	04/18/2018	Weather:		Coding:	RZMACP
MH#:	M-103-106	Owner:	NA	Len. Surveyed:	16.6
P.O.#:		Surveyor:	John Kuglmaier	Rim to Invert:	18.5
Customer:		Cert. #:	U-1215-07002349	Wall Material:	Concrete (reinforced)

Street:	39th Ave. 111' West of Maple St.	Project:	Hobart, IN
City:	Hobart, IN	GPS Northing:	2889667.892
Location:		GPS Easting:	2889667.892
Drain Area:	Northwest	GPS Accuracy:	Sub-Meter
Cover Shape:	Circular	Evidence of Surcharge:	No
Cover Size:	23.0	Potential for Runoff:	None
Comments:

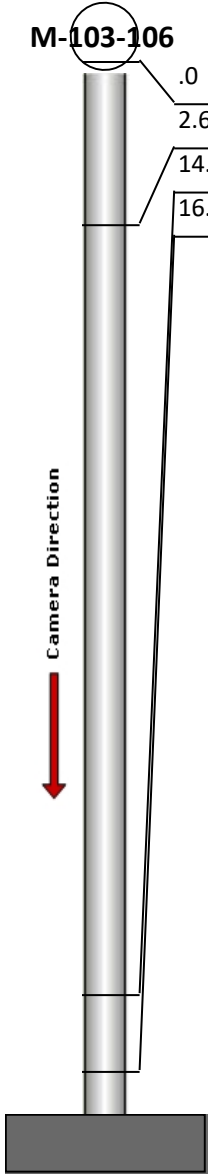
0.0	MGP	General Photo	10	NA
	2.6	MGP	General Photo	29	NA
	14.9	DSF	Deposits Settled Fine	67	M 2
	16.1	MGO	General Observation	81	NA
