Manhole Inspection Report

Date:	04/16/2018	Weather:		Coding:	RZMACP
MH#:	M-103-124	Owner:	NA	Len. Surveyed:	7.7
P.O.#:		Surveyor:	John Kuglmaier	Rim to Invert:	9.1
Customer:		Cert. #:	U-1215-07002349	Wall Material:	Concrete (reinforced)

Street:	Alley between Alabama St. and Map	Project:	Hobart, IN
City:	Hobart, IN	GPS Northing:	2889590.182
Location:		GPS Easting:	2889590.182
Drain Area:	Northwest	GPS Accuracy:	Sub-Meter
Cover Shape:	Circular	Evidence of Surcharge:	Yes
Cover Size:	23.0	Potential for Runoff:	None
Comments:

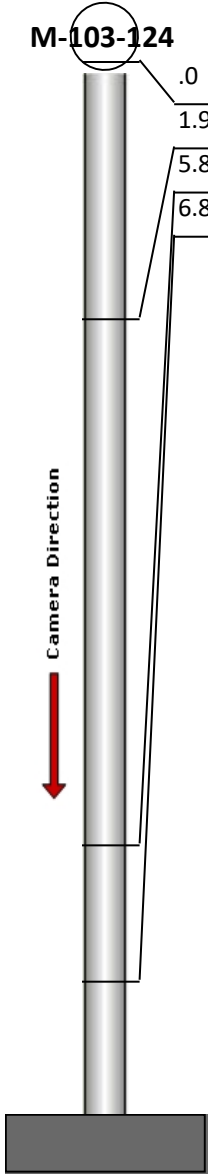
.0	MGP	General Photo	10	NA
	1.9	MGP	General Photo	28	NA
	5.8	DAZ	Deposits Attached Other	49	M 2
	6.8	MGO	General Observation	63	NA
