Manhole Inspection Report

Date:	04/16/2018	Weather:		Coding:	RZMACP
MH#:	M-103-130	Owner:	NA	Len. Surveyed:	6.3
P.O.#:		Surveyor:	John Kuglmaier	Rim to Invert:	7.4
Customer:		Cert. #:	U-1215-07002349	Wall Material:	Concrete (reinforced)

Street:	Alley between Swift St. and Alabam	Project:	Hobart, IN
City:	Hobart, IN	GPS Northing:	2889256.386
Location:		GPS Easting:	2889256.386
Drain Area:	Northwest	GPS Accuracy:	Sub-Meter
Cover Shape:	Circular	Evidence of Surcharge:	No
Cover Size:	23.0	Potential for Runoff:	None
Comments:

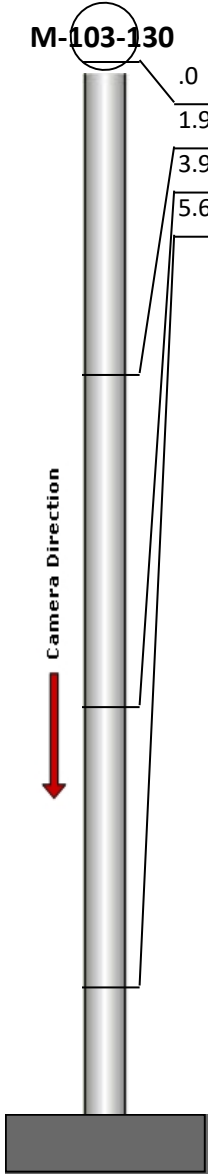
.0	MGP	General Photo	10	NA
	1.9	MGP	General Photo	28	NA
	3.9	DSF	Deposits Settled Fine	45	M 2
	5.6	MGO	General Observation	60	NA
