Manhole Inspection Report

Date:	03/20/2018	Weather:		Coding:	RZMACP
MH#:	M-108-012	Owner:	NA	Len. Surveyed:	3.0
P.O.#:		Surveyor:	John Kuglmaier	Rim to Invert:	3.3
Customer:		Cert. #:	U-1215-07002349	Wall Material:	Concrete (reinforced)

Street:	West 15th St. at Cul De Sac.	Project:	Hobart, IN
City:	Hobart, IN	GPS Northing:	2890395.979
Location:		GPS Easting:	2890395.979
Drain Area:	Southwest	GPS Accuracy:	Sub-Meter
Cover Shape:	Circular	Evidence of Surcharge:	No
Cover Size:	22.5	Potential for Runoff:	None
Comments:

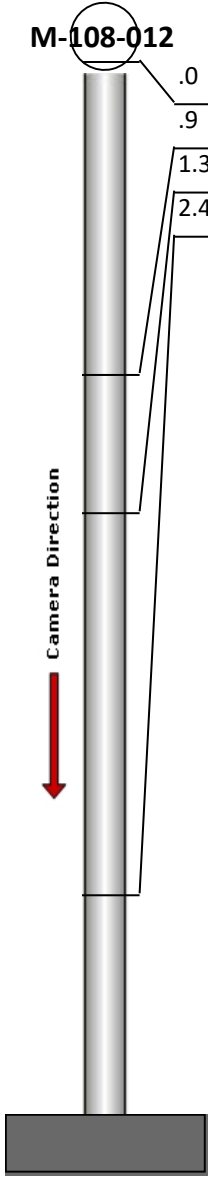
.0	MGP	General Photo	10	NA
	.9	DAZ	Deposits Attached Other	24	M 2
	1.3	MGP	General Photo	38	NA
	2.4	MGO	General Observation	54	NA
