Manhole Inspection Report

Date:	03/20/2018	Weather:		Coding:	RZMACP
MH#:	M-108-015	Owner:	NA	Len. Surveyed:	6.7
P.O.#:		Surveyor:	John Kuglmaier	Rim to Invert:	7.6
Customer:		Cert. #:	U-1215-07002349	Wall Material:	Concrete (reinforced)

Street:	14th Lane. and Maple St.	Project:	Hobart, IN
City:	Hobart, IN	GPS Northing:	2889909.139
Location:		GPS Easting:	2889909.139
Drain Area:	Southwest	GPS Accuracy:	Sub-Meter
Cover Shape:	Circular	Evidence of Surcharge:	No
Cover Size:	22.5	Potential for Runoff:	None
Comments:

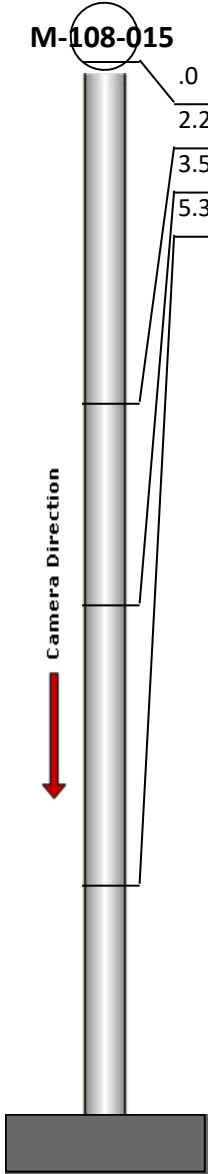
.0	MGP	General Photo	10	NA
	2.2	MGP	General Photo	28	NA
	3.5	DSF	Deposits Settled Fine	45	M 2
	5.3	MGO	General Observation	60	NA
