Manhole Inspection Report

Date:	03/21/2018	Weather:		Coding:	RZMACP
MH#:	M-108-024	Owner:	NA	Len. Surveyed:	6.1
P.O.#:		Surveyor:	John Kuglmaier	Rim to Invert:	6.6
Customer:		Cert. #:	U-1215-07002349	Wall Material:	Concrete (reinforced)

Street:	96' North of West 15th Pl. West of A	Project:	Hobart, IN
City:	Hobart, IN	GPS Northing:	0.0
Location:		GPS Easting:	0.0
Drain Area:	Southwest	GPS Accuracy:	Nearest Meter
Cover Shape:	Circular	Evidence of Surcharge:	Yes
Cover Size:	22.5	Potential for Runoff:	None
Comments:	AGAINST A FENCE

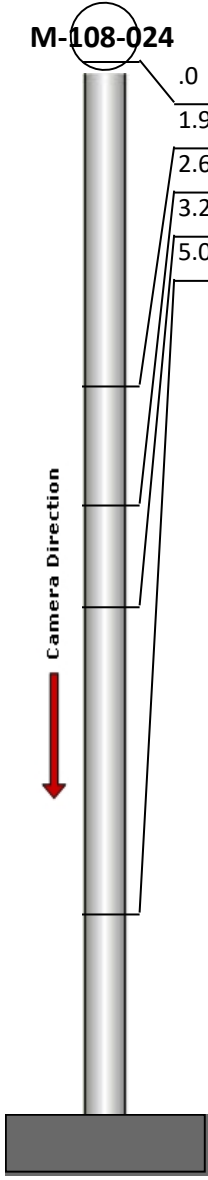
.0	MGP	General Photo	10	NA
	1.9	IS	Infil Stain	25	NA
	2.6	MGP	General Photo	40	NA
	3.2	DSF	Deposits Settled Fine	55	M 2
	5.0	MGO	General Observation	70	NA
