Manhole Inspection Report

Date:	03/20/2018	Weather:		Coding:	RZMACP
MH#:	M-108-027	Owner:	NA	Len. Surveyed:	9.4
P.O.#:		Surveyor:	John Kuglmaier	Rim to Invert:	9.8
Customer:		Cert. #:	U-1215-07002349	Wall Material:	Concrete (reinforced)

Street:	14th Ln. Alabama St. to the West.	Project:	Hobart, IN
City:	Hobart, IN	GPS Northing:	2889465.042
Location:		GPS Easting:	2889465.042
Drain Area:	Southwest	GPS Accuracy:	Sub-Meter
Cover Shape:	Circular	Evidence of Surcharge:	Yes
Cover Size:	22.5	Potential for Runoff:	None
Comments:

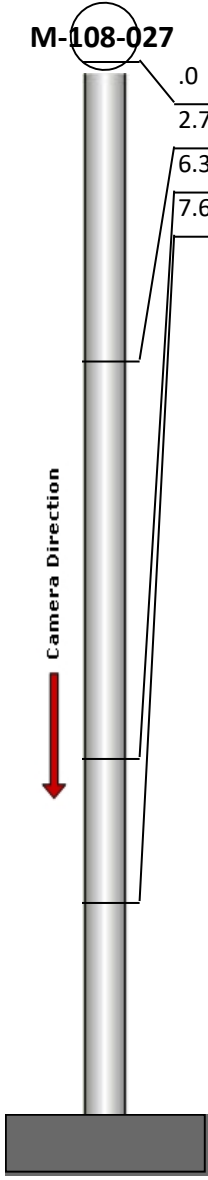
.0	MGP	General Photo	10	NA
	2.7	MGP	General Photo	29	NA
	6.3	DAZ	Deposits Attached Other	50	M 2
	7.6	MGO	General Observation	64	NA
