Manhole Inspection Report

Date:	03/21/2018	Weather:		Coding:	RZMACP
MH#:	M-108-035	Owner:	NA	Len. Surveyed:	11.9
P.O.#:		Surveyor:	John Kuglmaier	Rim to Invert:	12.2
Customer:		Cert. #:	U-1215-07002349	Wall Material:	Concrete (reinforced)

Street:	348' South of 57th Ave. Mississippi S	Project:	Hobart, IN
City:	Hobart, IN	GPS Northing:	0.0
Location:		GPS Easting:	0.0
Drain Area:	Southwest	GPS Accuracy:	Nearest Meter
Cover Shape:	Circular	Evidence of Surcharge:	Yes
Cover Size:	22.5	Potential for Runoff:	None
Comments:

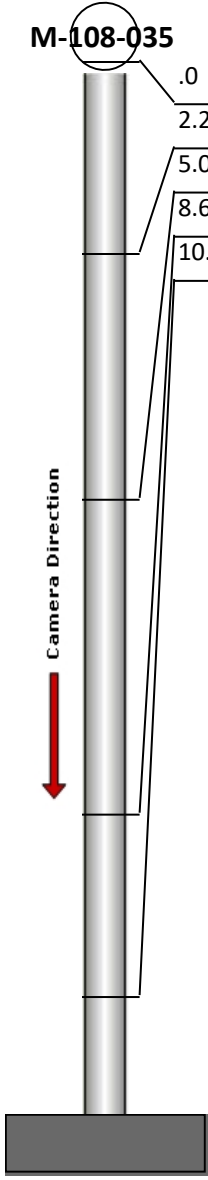
.0	MGP	General Photo	10	NA
	2.2	MGP	General Photo	28	NA
	5.0	IS	Infil Stain	48	NA
	8.6	IS	Infil Stain	67	NA
	10.7	MGO	General Observation	83	NA
