Manhole Inspection Report

Date:	03/21/2018	Weather:		Coding:	RZMACP
MH#:	M-108-040	Owner:	NA	Len. Surveyed:	6.0
P.O.#:		Surveyor:	John Kuglmaier	Rim to Invert:	6.6
Customer:		Cert. #:	U-1215-07002349	Wall Material:	Concrete (reinforced)

Street:	West 15th Pl. Swift St. to the Southe	Project:	Hobart, IN
City:	Hobart, IN	GPS Northing:	0.0
Location:		GPS Easting:	0.0
Drain Area:	Southwest	GPS Accuracy:	Nearest Meter
Cover Shape:	Circular	Evidence of Surcharge:	No
Cover Size:	22.5	Potential for Runoff:	None
Comments:

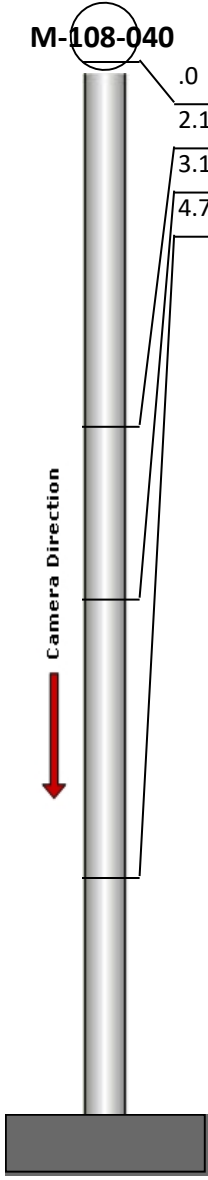
.0	MGP	General Photo	10	NA
	2.1	MGP	General Photo	28	NA
	3.1	DAZ	Deposits Attached Other	44	M 2
	4.7	MGO	General Observation	59	NA
