Manhole Inspection Report

Date:	03/22/2018	Weather:		Coding:	RZMACP
MH#:	M-108-043	Owner:	NA	Len. Surveyed:	8.5
P.O.#:		Surveyor:	John Kuglmaier	Rim to Invert:	8.9
Customer:		Cert. #:	U-1215-07002349	Wall Material:	Concrete (reinforced)

Street:	West 15th Pl. Mississippi St. to the	Project:	Hobart, IN
City:	Hobart, IN	GPS Northing:	0.0
Location:		GPS Easting:	0.0
Drain Area:	Southwest	GPS Accuracy:	Nearest Meter
Cover Shape:	Circular	Evidence of Surcharge:	Yes
Cover Size:	22.5	Potential for Runoff:	None
Comments:

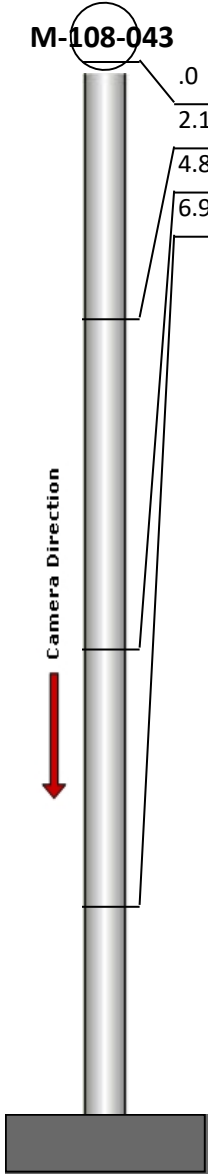
.0	MGP	General Photo	10	NA
	2.1	MGP	General Photo	28	NA
	4.8	DAZ	Deposits Attached Other	47	M 2
	6.9	MGO	General Observation	62	NA
