Manhole Inspection Report

Date:	03/21/2018	Weather:		Coding:	RZMACP
MH#:	M-108-045	Owner:	NA	Len. Surveyed:	11.2
P.O.#:		Surveyor:	John Kuglmaier	Rim to Invert:	11.4
Customer:		Cert. #:	U-1215-07002349	Wall Material:	Concrete (reinforced)

Street:	Mississippi St. 584' South of 57th Av	Project:	Hobart, IN
City:	Hobart, IN	GPS Northing:	0.0
Location:		GPS Easting:	0.0
Drain Area:	Southwest	GPS Accuracy:	Nearest Meter
Cover Shape:	Circular	Evidence of Surcharge:	Yes
Cover Size:	22.5	Potential for Runoff:	None
Comments:

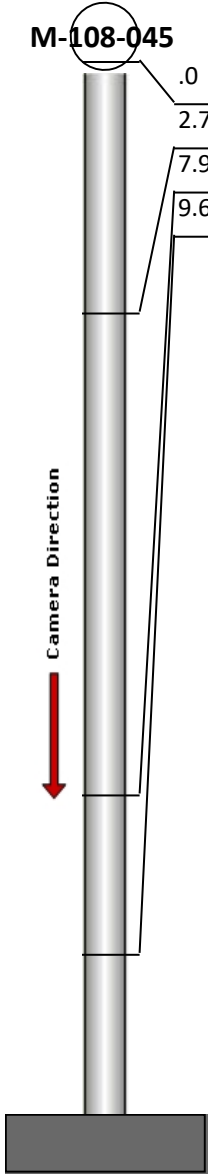
.0	MGP	General Photo	10	NA
	2.7	MGP	General Photo	29	NA
	7.9	DAZ	Deposits Attached Other	53	M 2
	9.6	MGO	General Observation	68	NA
