# Manhole Inspection Report

Date:	<b>09/20/2022</b>	Weather:		Coding:	<b>RZMACP</b>
MH#:	<b>M-203-019</b>	Owner:	<b>NA</b>	Len. Surveyed:	<b>5.2</b>
P.O.#:		Surveyor:	<b>Jen Costello</b>	Rim to Invert:	<b>6.0</b>
Customer:		Cert. #:	<b>U-907-5518</b>	Wall Material:	<b>Concrete (cast in place)</b>

Street:	<b>161' South of 37th Ave. On Parker St</b>	Project:	<b>Hobart, IN</b>
City:	<b>Hobart, IN</b>	GPS Northing:	<b>2295693.883</b>
Location:	<b>Yard</b>	GPS Easting:	<b>2893763.674</b>
Drain Area:	<b>Northwest</b>	GPS Accuracy:	<b>Sub-Meter</b>
Cover Shape:	<b>Circular</b>	Evidence of Surcharge:	<b>Yes</b>
Cover Size:	<b>24.0</b>	Potential for Runoff:	<b>None</b>
Comments:

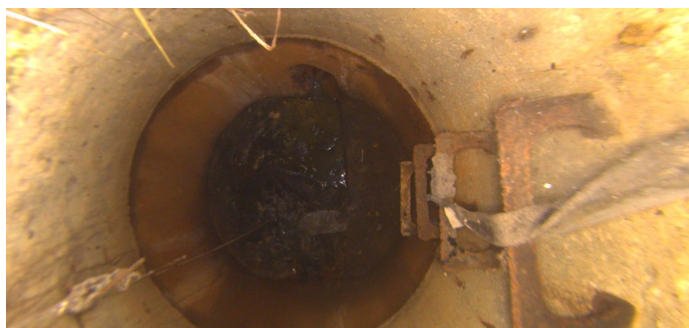
Code: **MGO**  
Description: **General Observation**

Distance (ft): **.0**  
Structural Grade: **0**  
O&M Grade: **0**  
Clock Start/From:  
Clock To:  
1st Value:  
2nd Value:  
Value Percent:  
Step: **NO**  
Remarks: **access mh**

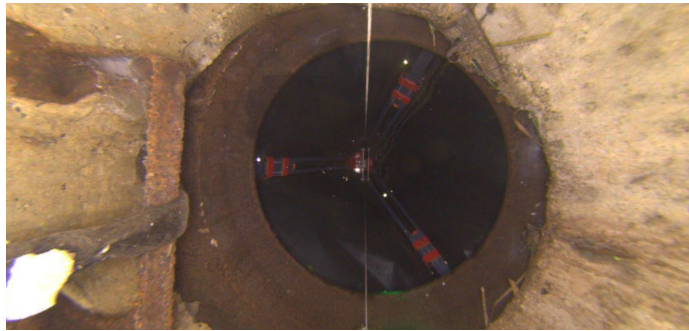
Code: **MGO**  
Description: **General Observation**

Distance (ft): **2.0**  
Structural Grade: **0**  
O&M Grade: **0**  
Clock Start/From:  
Clock To:  
1st Value:  
2nd Value:  
Value Percent:  
Step: **NO**  
Remarks: **underside of frame**

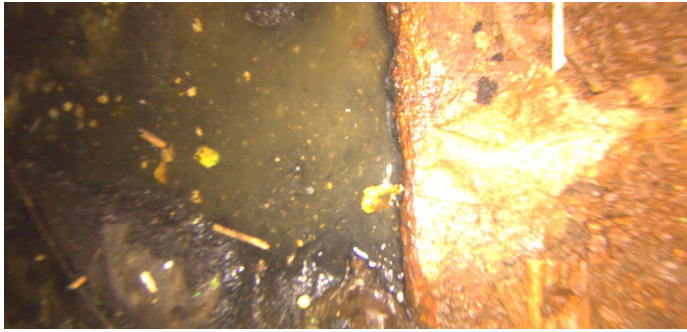
Code:	<b>MGO</b>
Description:	<b>General Observation</b>
Distance (ft):	<b>4.9</b>
Structural Grade:	<b>0</b>
O&M Grade:	<b>0</b>
Clock Start/From:	
Clock To:	
1st Value:	
2nd Value:	
Value Percent:	
Step:	<b>NO</b>
Remarks:	<b>end of survey</b>
