# Manhole Inspection Report

Date:	04/17/2018	Weather:		Coding:	RZMACP
MH#:	M-203-040	Owner:	NA	Len. Surveyed:	2.1
P.O.#:		Surveyor:	Jen Costello	Rim to Invert:	3.0
Customer:		Cert. #:	U-907-5518	Wall Material:	Concrete (reinforced)

Street:	Alley between 37th Ave. and 38th A	Project:	Hobart, IN
City:	Hobart, IN	GPS Northing:	0.0
Location:		GPS Easting:	0.0
Drain Area:	Northwest	GPS Accuracy:	Nearest Meter
Cover Shape:	Circular	Evidence of Surcharge:	No
Cover Size:	23.0	Potential for Runoff:	None
Comments:

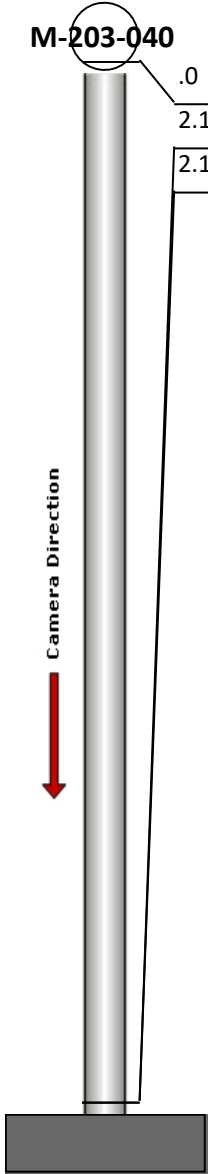
M-203-040				
	.0	MGO	General Observation	10	NA
	2.1	MGO	General Observation	24	NA
	2.1	SAV	Surface Aggregate Visible	35	S 3
