Manhole Inspection Report

Date:	04/17/2018	Weather:		Coding:	RZMACP
MH#:	M-203-042	Owner:	NA	Len. Surveyed:	9.0
P.O.#:		Surveyor:	Jen Costello	Rim to Invert:	10.0
Customer:		Cert. #:	U-907-5518	Wall Material:	Concrete (reinforced)

Street:	between Evergreen St. and Maitland	Project:	Hobart, IN
City:	Hobart, IN	GPS Northing:	0.0
Location:		GPS Easting:	0.0
Drain Area:	Northwest	GPS Accuracy:	Nearest Meter
Cover Shape:	Circular	Evidence of Surcharge:	No
Cover Size:	23.0	Potential for Runoff:	None
Comments:

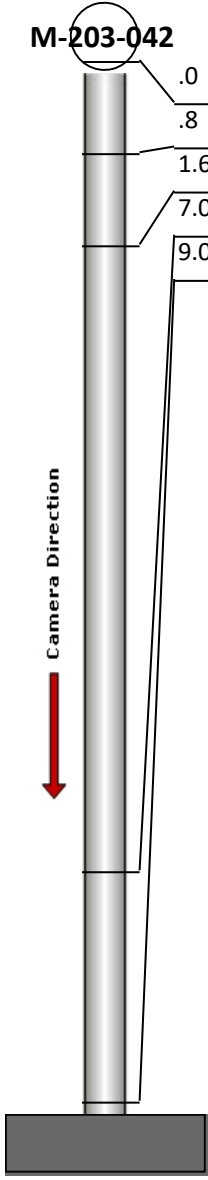
.0	MGO	General Observation	10	NA
	.8	SAP	Surface Aggregate Projecting	23	S 3
	1.6	MGO	General Observation	38	NA
	7.0	SAV	Surface Aggregate Visible	63	S 3
	9.0	MGO	General Observation	78	NA
