# Manhole Inspection Report

Date:	<b>04/17/2018</b>	Weather:		Coding:	<b>RZMACP</b>
MH#:	<b>M-203-044</b>	Owner:	<b>NA</b>	Len. Surveyed:	<b>1.5</b>
P.O.#:		Surveyor:	<b>Jen Costello</b>	Rim to Invert:	<b>2.4</b>
Customer:		Cert. #:	<b>U-907-5518</b>	Wall Material:	<b>Concrete (reinforced)</b>

Street:	<b>Maitland St. 150' North of 39th Ave.</b>	Project:	<b>Hobart, IN</b>
City:	<b>Hobart, IN</b>	GPS Northing:	<b>0.0</b>
Location:		GPS Easting:	<b>0.0</b>
Drain Area:	<b>Northwest</b>	GPS Accuracy:	<b>Nearest Meter</b>
Cover Shape:	<b>Circular</b>	Evidence of Surcharge:	<b>No</b>
Cover Size:	<b>23.0</b>	Potential for Runoff:	<b>None</b>
Comments:

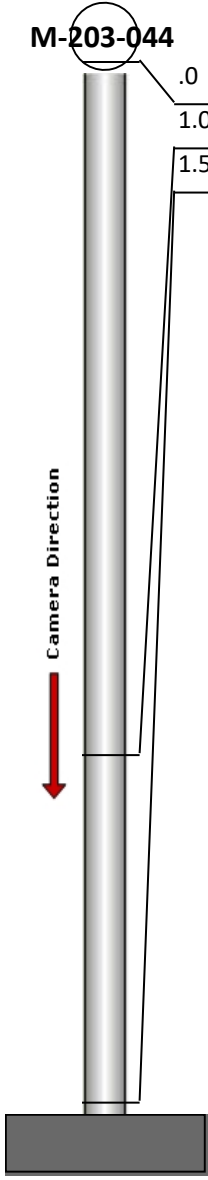
M-203-044				
	.0	MGO	General Observation	10	NA
	1.0	SAV	Surface Aggregate Visible	24	S 3
	1.5	MGO	General Observation	36	NA
