Manhole Inspection Report

Date:	04/17/2018	Weather:		Coding:	RZMACP
MH#:	M-203-045	Owner:	NA	Len. Surveyed:	8.2
P.O.#:		Surveyor:	Jen Costello	Rim to Invert:	9.3
Customer:		Cert. #:	U-907-5518	Wall Material:	Concrete (reinforced)

Street:	Alley between 38th Ave and 39th Av	Project:	Hobart, IN
City:	Hobart, IN	GPS Northing:	0.0
Location:		GPS Easting:	0.0
Drain Area:	Northwest	GPS Accuracy:	Nearest Meter
Cover Shape:	Circular	Evidence of Surcharge:	No
Cover Size:	23.0	Potential for Runoff:	None
Comments:

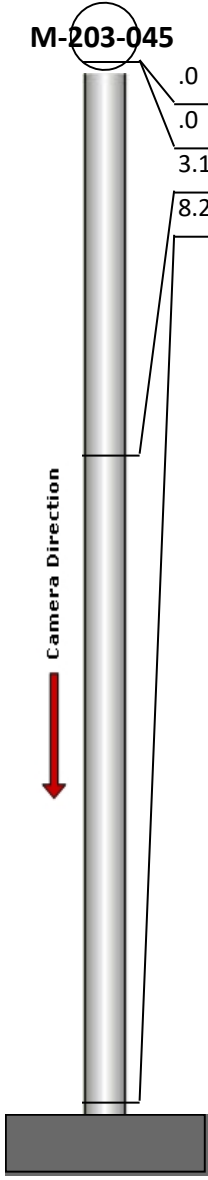
.0	MGO	General Observation	10	NA
	.0	SRI	Surface Roughness Increased	21	S 1
	3.1	RFJ	Roots Fine Joint	39	M 1
	8.2	MGO	General Observation	60	NA
