Manhole Inspection Report

| MH#: | M-208-003 | Owner: | NA | Len. Surveyed: | 10.2 |

| Street: | Between 58th Pl. and 59th Pl. 147' E | Project: | Hobart, IN |

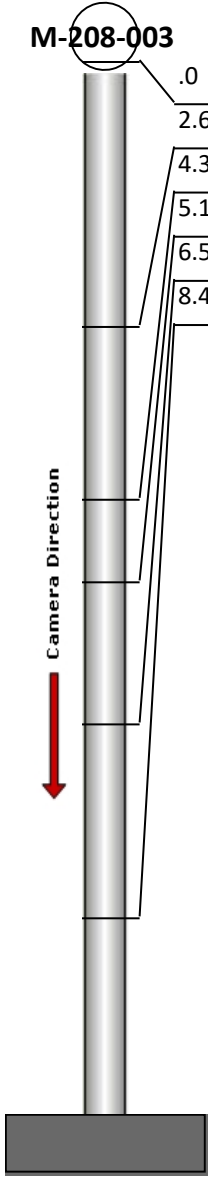
| | Position | Code | Observation | Video (sec) | Grade |
|--|---|---|---|---|---|
| | 4.3 | RFJ | Roots Fine Joint | 46 | M 1 |
| | 5.1 | IS | Infil Stain | 60 | NA |
| | 6.5 | DSF | Deposits Settled Fine | 74 | M 3 |
| | 8.4 | MGO | General Observation | 89 | NA |
