Manhole Inspection Report

Date:	03/26/2018	Weather:		Coding:	RZMACP
MH#:	M-208-018	Owner:	NA	Len. Surveyed:	12.8
P.O.#:		Surveyor:	John Kuglmaier	Rim to Invert:	12.9
Customer:		Cert. #:	U-1215-07002349	Wall Material:	Concrete (reinforced)

Street:	59th Pl. Brookview Ct. to the North	Project:	Hobart, IN
City:	Hobart, IN	GPS Northing:	0.0
Location:		GPS Easting:	0.0
Drain Area:	Southwest	GPS Accuracy:	Nearest Meter
Cover Shape:	Circular	Evidence of Surcharge:	No
Cover Size:	22.5	Potential for Runoff:	None
Comments:

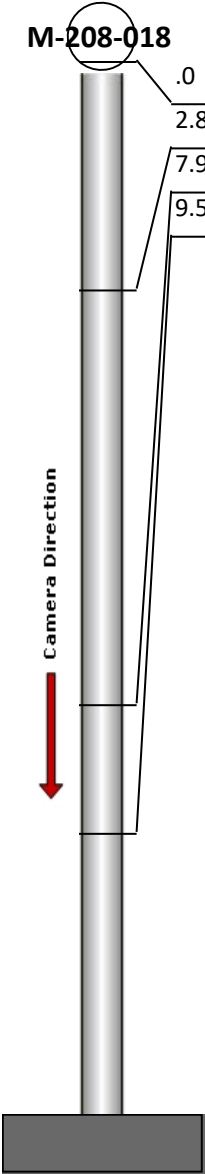
M-208-018				
	.0	MGP	General Photo	10	NA
	2.8	MGP	General Photo	30	NA
	7.9	DAZ	Deposits Attached Other	53	M 3
	9.5	MGO	General Observation	68	NA
