Manhole Inspection Report

Date:	03/26/2018	Weather:		Coding:	RZMACP
MH#:	M-208-019	Owner:	NA	Len. Surveyed:	11.7
P.O.#:		Surveyor:	John Kuglmaier	Rim to Invert:	13.1
Customer:		Cert. #:	U-1215-07002349	Wall Material:	Concrete (reinforced)

Street:	266' South of 58th Pl. West of Brook	Project:	Hobart, IN
City:	Hobart, IN	GPS Northing:	0.0
Location:		GPS Easting:	0.0
Drain Area:	Southwest	GPS Accuracy:	Nearest Meter
Cover Shape:	Circular	Evidence of Surcharge:	Yes
Cover Size:	22.5	Potential for Runoff:	None
Comments:

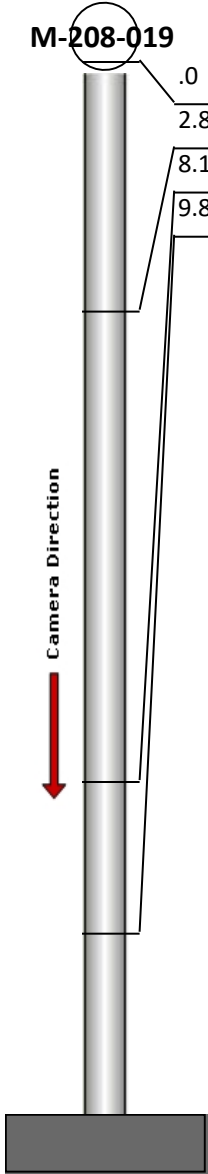
.0	MGP	General Photo	10	NA
	2.8	MGP	General Photo	29	NA
	8.1	DAZ	Deposits Attached Other	53	M 3
	9.8	MGO	General Observation	68	NA
