Manhole Inspection Report

Date:	03/22/2018	Weather:		Coding:	RZMACP
MH#:	M-208-022A	Owner:	NA	Len. Surveyed:	8.6
P.O.#:		Surveyor:	John Kuglmaier	Rim to Invert:	9.1
Customer:		Cert. #:	U-1215-07002349	Wall Material:	Concrete (reinforced)

Street:	Liverpool Rd. ACROSS FROM W 60T	Project:	Hobart, IN
City:	Hobart, IN	GPS Northing:	0.0
Location:		GPS Easting:	0.0
Drain Area:	Southwest	GPS Accuracy:	Nearest Meter
Cover Shape:	Circular	Evidence of Surcharge:	Yes
Cover Size:	22.5	Potential for Runoff:	None
Comments:	NEW MANHOLE

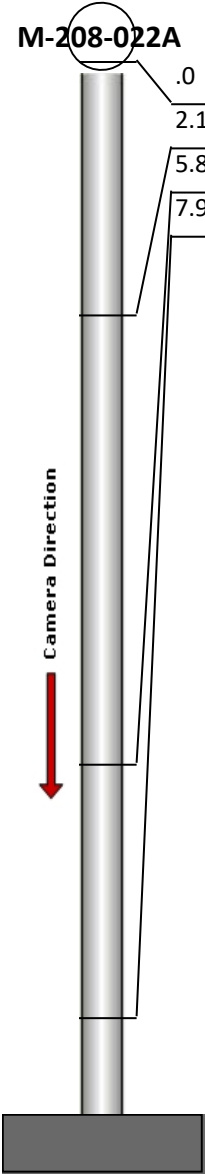
.0	MGP	General Photo	10	NA
	2.1	MGP	General Photo	28	NA
	5.8	DSF	Deposits Settled Fine	49	M 2
	7.9	MGO	General Observation	65	NA
