Manhole Inspection Report

Date:	03/25/2018	Weather:		Coding:	RZMACP
MH#:	M-209-003	Owner:	NA	Len. Surveyed:	7.4
P.O.#:		Surveyor:	John Kuglmaier	Rim to Invert:	8.3
Customer:		Cert. #:	U-1215-07002349	Wall Material:	Concrete (reinforced)

Street:	North of 61st Ln. 420' East of Orego	Project:	Hobart, IN
City:	Hobart, IN	GPS Northing:	0.0
Location:		GPS Easting:	0.0
Drain Area:	Southwest	GPS Accuracy:	Nearest Meter
Cover Shape:	Circular	Evidence of Surcharge:	No
Cover Size:	22.5	Potential for Runoff:	None
Comments:

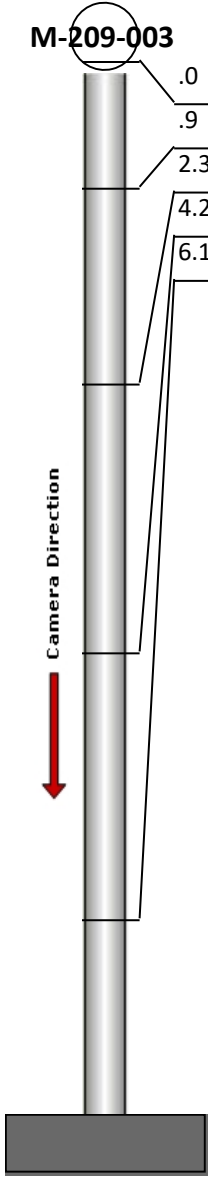
.0	MGP	General Photo	10	NA
	.9	IS	Infil Stain	23	NA
	2.3	MGP	General Photo	40	NA
	4.2	DSF	Deposits Settled Fine	57	M 3
	6.1	MGO	General Observation	73	NA
