Manhole Inspection Report

Date:	03/22/2018	Weather:		Coding:	RZMACP
MH#:	M-209-020	Owner:	NA	Len. Surveyed:	11.9
P.O.#:		Surveyor:	John Kuglmaier	Rim to Invert:	12.2
Customer:		Cert. #:	U-1215-07002349	Wall Material:	Concrete (reinforced)

Street:	61st Pl. 137' West of California St.	Project:	Hobart, IN
City:	Hobart, IN	GPS Northing:	0.0
Location:		GPS Easting:	0.0
Drain Area:	Southwest	GPS Accuracy:	Nearest Meter
Cover Shape:	Circular	Evidence of Surcharge:	Yes
Cover Size:	22.5	Potential for Runoff:	None
Comments:

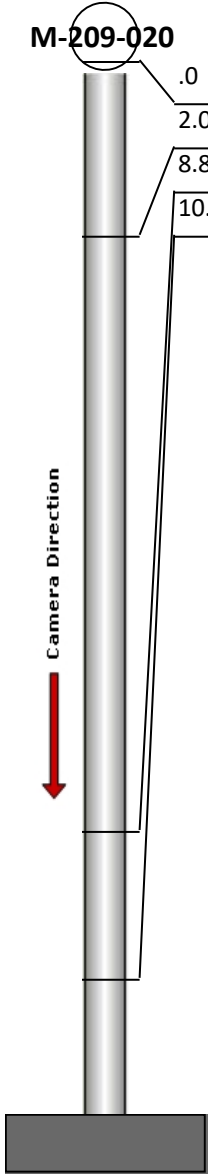
.0	MGP	General Photo	10	NA
	2.0	MGP	General Photo	28	NA
	8.8	DAZ	Deposits Attached Other	55	M 2
	10.5	MGO	General Observation	70	NA
