Manhole Inspection Report

Date:	04/19/2018	Weather:		Coding:	RZMACP
MH#:	M-303-029	Owner:	NA	Len. Surveyed:	4.9
P.O.#:		Surveyor:	Jen Costello	Rim to Invert:	6.6
Customer:		Cert. #:	U-907-5518	Wall Material:	Concrete (reinforced)

Street:	Kenwood St. and 38th Ave to the So	Project:	Hobart, IN
City:	Hobart, IN	GPS Northing:	2894746.598
Location:		GPS Easting:	2894746.598
Drain Area:	Northwest	GPS Accuracy:	Sub-Meter
Cover Shape:	Circular	Evidence of Surcharge:	No
Cover Size:	23.0	Potential for Runoff:	None
Comments:

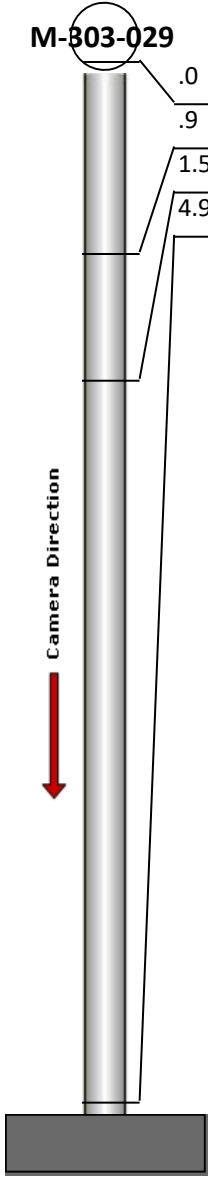
.0	MGO	General Observation	10	NA
	.9	RFJ	Roots Fine Joint	23	M 1
	1.5	MGO	General Observation	38	NA
	4.9	MGO	General Observation	57	NA
