Manhole Inspection Report

Date:	04/13/2018	Weather:		Coding:	RZMACP
MH#:	M-303-033	Owner:	NA	Len. Surveyed:	6.0
P.O.#:		Surveyor:	Jen Costello	Rim to Invert:	13.0
Customer:		Cert. #:	U-907-5518	Wall Material:	Concrete (reinforced)

Street:	Ridgelawn St. 168' North of 38th Av	Project:	Hobart, IN
City:	Hobart, IN	GPS Northing:	0.0
Location:		GPS Easting:	0.0
Drain Area:	Northwest	GPS Accuracy:	Nearest Meter
Cover Shape:	Circular	Evidence of Surcharge:	No
Cover Size:	23.0	Potential for Runoff:	None
Comments:

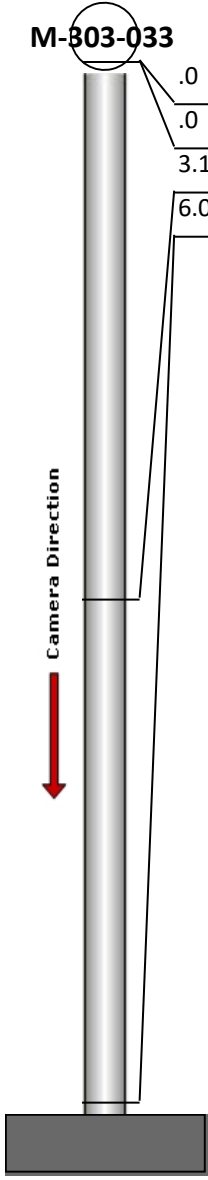
.0	MGO	General Observation	10	NA
	.0	SAV	Surface Aggregate Visible	21	S 3
	3.1	MGO	General Observation	41	NA
	6.0	OBP	Obstacle External Pipe or Cable	61	M 3
