# Manhole Inspection Report

Date:	<b>04/13/2018</b>	Weather:		Coding:	<b>RZMACP</b>
MH#:	<b>M-303-038</b>	Owner:	<b>NA</b>	Len. Surveyed:	<b>6.6</b>
P.O.#:		Surveyor:	<b>Jen Costello</b>	Rim to Invert:	<b>8.3</b>
Customer:		Cert. #:	<b>U-907-5518</b>	Wall Material:	<b>Concrete (reinforced)</b>

Street:	<b>Roche St. 416' South of 38th Ave.</b>	Project:	<b>Hobart, IN</b>
City:	<b>Hobart, IN</b>	GPS Northing:	<b>0.0</b>
Location:		GPS Easting:	<b>0.0</b>
Drain Area:	<b>Northwest</b>	GPS Accuracy:	<b>Nearest Meter</b>
Cover Shape:	<b>Circular</b>	Evidence of Surcharge:	<b>No</b>
Cover Size:	<b>23.0</b>	Potential for Runoff:	<b>None</b>
Comments:

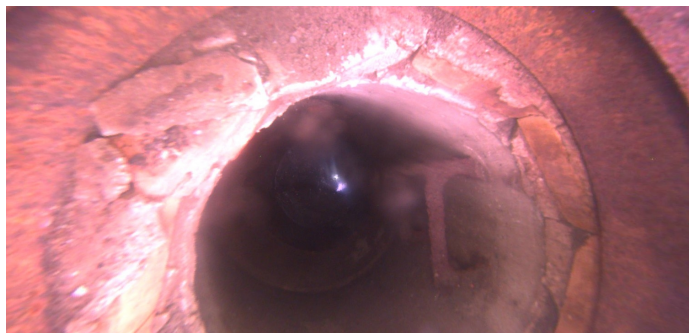
Code: **MGO**  
Description: **General Observation**

Distance (ft): **.0**  
Structural Grade: **0**  
O&M Grade: **0**  
Clock Start/From:  
Clock To:  
1st Value:  
2nd Value:  
Value Percent:  
Step: **NO**  
Remarks: **END SURVEY**
