Manhole Inspection Report

Date:	04/13/2018	Weather:		Coding:	RZMACP
MH#:	M-303-039	Owner:	NA	Len. Surveyed:	7.2
P.O.#:		Surveyor:	Jen Costello	Rim to Invert:	8.3
Customer:		Cert. #:	U-907-5518	Wall Material:	Concrete (reinforced)

Street:	Intersection of 38th Ave. and Roche	Project:	Hobart, IN
City:	Hobart, IN	GPS Northing:	0.0
Location:		GPS Easting:	0.0
Drain Area:	Northwest	GPS Accuracy:	Nearest Meter
Cover Shape:	Circular	Evidence of Surcharge:	No
Cover Size:	23.0	Potential for Runoff:	None
Comments:

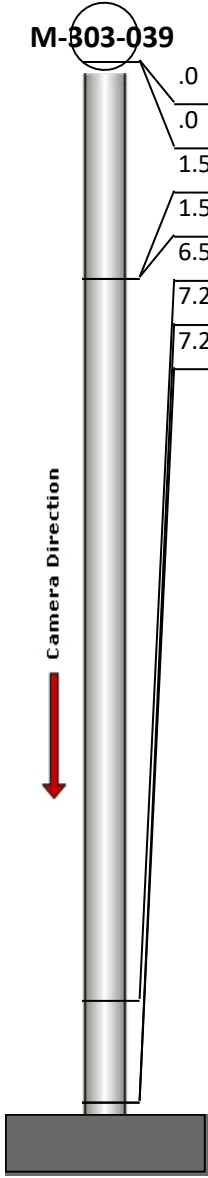
.0	MGO	General Observation	10	NA
	.0	SRV	Surface Reinforcement Visible	21	S 5
	1.5	MGP	General Photo	37	NA
	1.5	B	Broken	48	S 5
	6.5	DSF	Deposits Settled Fine	70	M 2
	7.2	MGO	General Observation	82	NA
	7.2	SRV	Surface Reinforcement Visible	92	S 5
