Manhole Inspection Report

Date:	04/12/2018	Weather:		Coding:	RZMACP
MH#:	M-303-070	Owner:	NA	Len. Surveyed:	3.3
P.O.#:		Surveyor:	John Kuglmaier	Rim to Invert:	4.5
Customer:		Cert. #:	U-1215-07002349	Wall Material:	Concrete (reinforced)

Street:	39th Ave. 387' East of Ridgelawn St.	Project:	Hobart, IN
City:	Hobart, IN	GPS Northing:	2895766.838
Location:		GPS Easting:	2895766.838
Drain Area:	Northwest	GPS Accuracy:	Sub-Meter
Cover Shape:	Circular	Evidence of Surcharge:	No
Cover Size:	23.0	Potential for Runoff:	None
Comments:

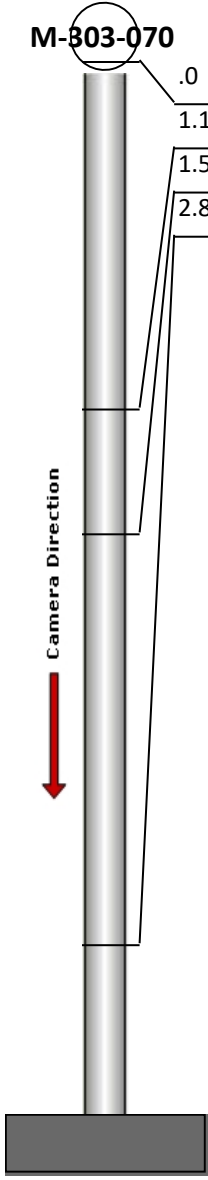
.0	MGP	General Photo	10	NA
	1.1	DAZ	Deposits Attached Other	24	M 2
	1.5	MGP	General Photo	38	NA
	2.8	MGO	General Observation	55	NA
