Manhole Inspection Report

Date:	05/06/2018	Weather:		Coding:	RZMACP
MH#:	M-305-013	Owner:	NA	Len. Surveyed:	5.9
P.O.#:		Surveyor:	Jen Costello	Rim to Invert:	6.6
Customer:		Cert. #:	U-907-5518	Wall Material:	Concrete (reinforced)

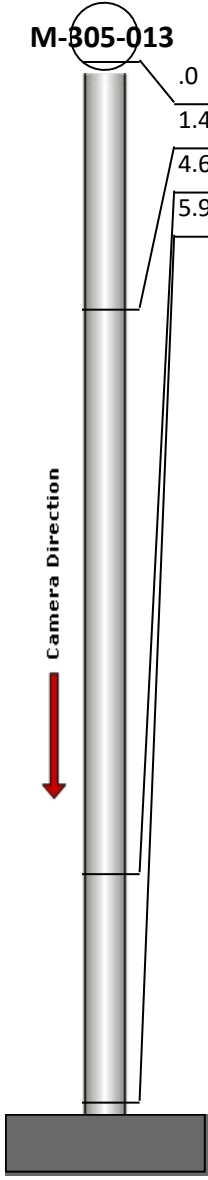
.0	MGO	General Observation	10	NA
	1.4	MGO	General Observation	26	NA
	4.6	DSF	Deposits Settled Fine	46	M 2
	5.9	MGO	General Observation	60	NA
