Manhole Inspection Report

Date:	05/17/2018	Weather:		Coding:	RZMACP
MH#:	M-305-014	Owner:	NA	Len. Surveyed:	8.1
P.O.#:		Surveyor:	Jen Costello	Rim to Invert:	8.8
Customer:		Cert. #:	U-907-5518	Wall Material:	Concrete (reinforced)

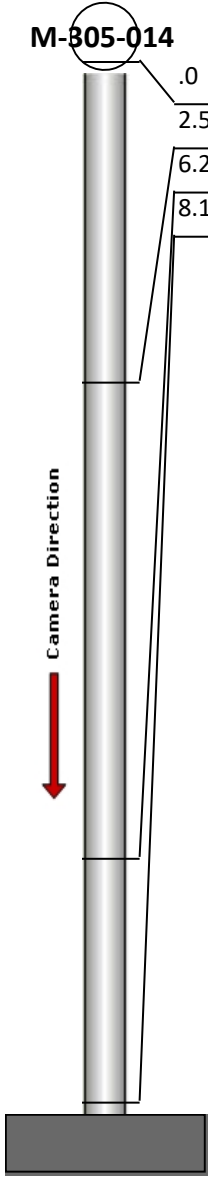
Position	Code	Observation	Video (sec)	Grade

.0	MGO	General Observation	10	NA
	2.5	MGO	General Observation	29	NA
	6.2	DSF	Deposits Settled Fine	50	M 2
	8.1	MGO	General Observation	65	NA
