Manhole Inspection Report

Date:	04/20/2018	Weather:		Coding:	RZMACP
MH#:	M-305-024	Owner:	NA	Len. Surveyed:	7.0
P.O.#:		Surveyor:	Jen Costello	Rim to Invert:	8.8
Customer:		Cert. #:	U-907-5518	Wall Material:	Concrete (reinforced)

Street:	W. 3rd Pl. 151' East of Woodland Ct.	Project:	Hobart, IN
City:	Hobart, IN	GPS Northing:	0.0
Location:		GPS Easting:	0.0
Drain Area:	West	GPS Accuracy:	Nearest Meter
Cover Shape:	Circular	Evidence of Surcharge:	No
Cover Size:	23.0	Potential for Runoff:	None
Comments:

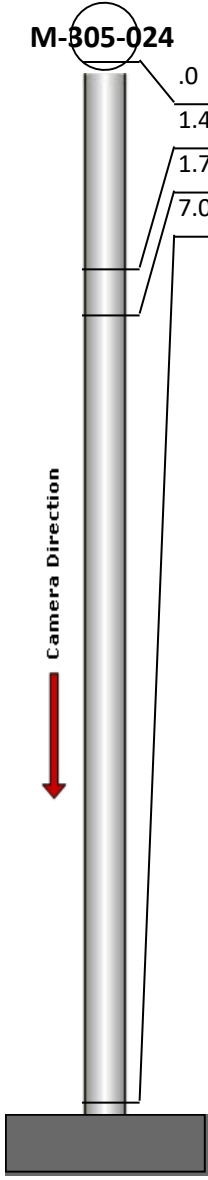
.0	MGO	General Observation	11	NA
	1.4	MGP	General Photo	27	NA
	1.7	OBP	Obstacle External Pipe or Cable	41	M 2
	7.0	MGO	General Observation	64	NA
