Manhole Inspection Report

Date:	04/28/2018	Weather:		Coding:	RZMACP
MH#:	M-305-056	Owner:	NA	Len. Surveyed:	5.1
P.O.#:		Surveyor:	Jen Costello	Rim to Invert:	6.4
Customer:		Cert. #:	U-907-5518	Wall Material:	Brick

Street:	West 2nd Pl. and Crestwood Dr. to t	Project:	Hobart, IN
City:	Hobart, IN	GPS Northing:	2896784.627
Location:		GPS Easting:	2896784.627
Drain Area:	West	GPS Accuracy:	Sub-Meter
Cover Shape:	Circular	Evidence of Surcharge:	No
Cover Size:	23.0	Potential for Runoff:	None
Comments:

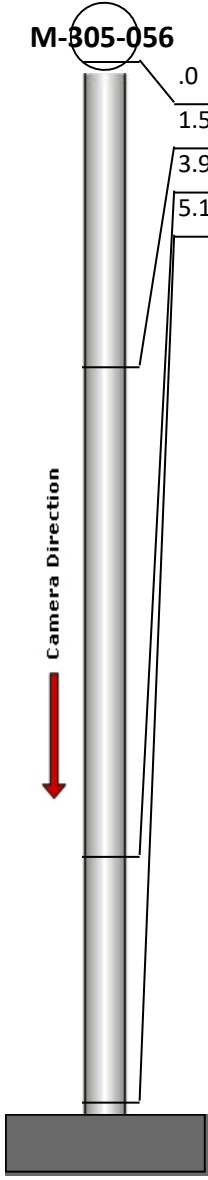
.0	MGO	General Observation	11	NA
	1.5	MGP	General Photo	27	NA
	3.9	OBR	Obstacle Rocks	45	M 2
	5.1	MGO	General Observation	60	NA
