Manhole Inspection Report

| MH#: | M-308-006 | Owner: | NA | Len. Surveyed: | 20.2 |

| Street: | 61st Ave. 881' East of Amber Dr. | Project: | Hobart, IN |

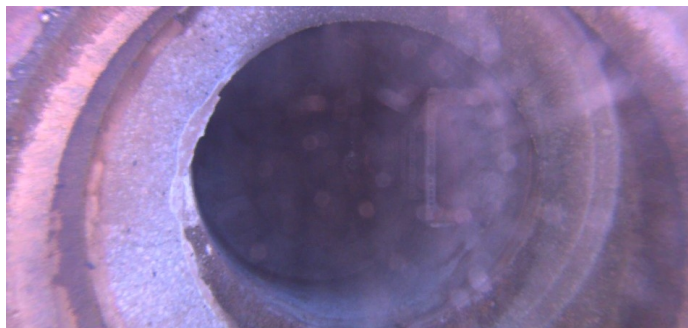
Code: **MGP**
Description: **General Photo**

Distance (ft): **.0**
Structural Grade: **0**
O&M Grade: **0**
Clock Start/From:
Clock To:
1st Value:
2nd Value:
Value Percent:
Step: **NO**
Remarks:

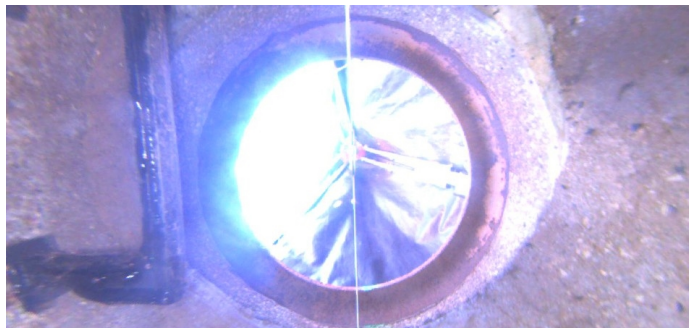
| Code: | MGP |
| Description: | General Photo |
