Manhole Inspection Report

Date:	03/27/2018	Weather:		Coding:	RZMACP
MH#:	M-308-019	Owner:	NA	Len. Surveyed:	11.5
P.O.#:		Surveyor:	John Kuglmaier	Rim to Invert:	12.2
Customer:		Cert. #:	U-1215-07002349	Wall Material:	Concrete (reinforced)

Street:	Diamond Dr. 298' West of Amber Dr.	Project:	Hobart, IN
City:	Hobart, IN	GPS Northing:	0.0
Location:		GPS Easting:	0.0
Drain Area:	Southwest	GPS Accuracy:	Nearest Meter
Cover Shape:	Circular	Evidence of Surcharge:	No
Cover Size:	22.5	Potential for Runoff:	None
Comments:

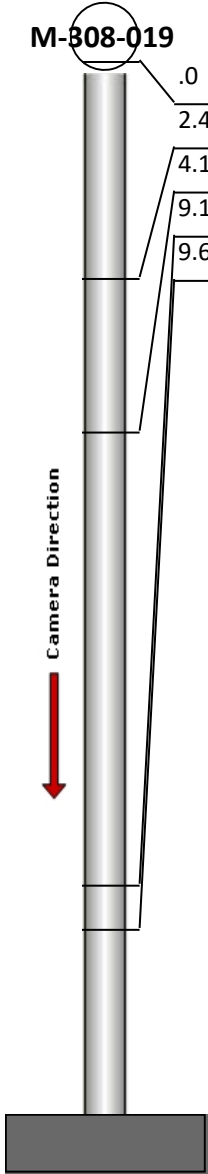
M-308-019				
	.0	MGP	General Photo	10	NA
	2.4	MGP	General Photo	29	NA
	4.1	IS	Infil Stain	46	NA
	9.1	IS	Infil Stain	69	NA
	9.6	MGO	General Observation	81	NA
