Manhole Inspection Report

Date:	03/27/2018	Weather:		Coding:	RZMACP
MH#:	M-308-022	Owner:	NA	Len. Surveyed:	7.5
P.O.#:		Surveyor:	John Kuglmaier	Rim to Invert:	8.2
Customer:		Cert. #:	U-1215-07002349	Wall Material:	Concrete (reinforced)

Street:	Colorado St. 141' Northeast of Diam	Project:	Hobart, IN
City:	Hobart, IN	GPS Northing:	0.0
Location:		GPS Easting:	0.0
Drain Area:	Southwest	GPS Accuracy:	Nearest Meter
Cover Shape:	Circular	Evidence of Surcharge:	Yes
Cover Size:	22.5	Potential for Runoff:	None
Comments:

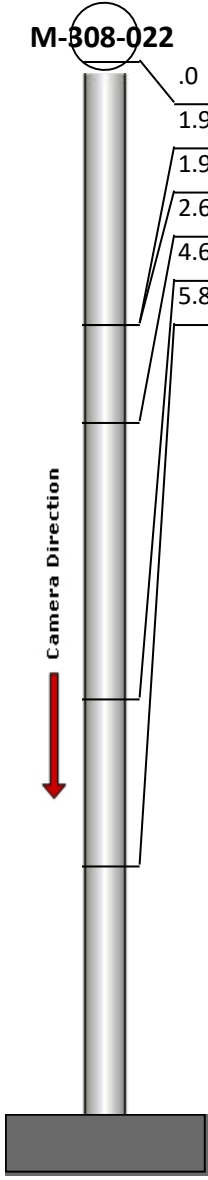
.0	MGP	General Photo	10	NA
	1.9	HSV	Hole Soil Visible	26	S 5
	1.9	IS	Infil Stain	37	NA
	2.6	MGP	General Photo	52	NA
	4.6	DSF	Deposits Settled Fine	70	M 2
	5.8	MGO	General Observation	84	NA
