Manhole Inspection Report

Date:	03/27/2018	Weather:		Coding:	RZMACP
MH#:	M-308-024	Owner:	NA	Len. Surveyed:	5.9
P.O.#:		Surveyor:	John Kuglmaier	Rim to Invert:	6.7
Customer:		Cert. #:	U-1215-07002349	Wall Material:	Concrete (reinforced)

Street:	Emerald Dr. Colorado St.	Project:	Hobart, IN
City:	Hobart, IN	GPS Northing:	0.0
Location:		GPS Easting:	0.0
Drain Area:	Southwest	GPS Accuracy:	Nearest Meter
Cover Shape:	Circular	Evidence of Surcharge:	No
Cover Size:	22.5	Potential for Runoff:	None
Comments:

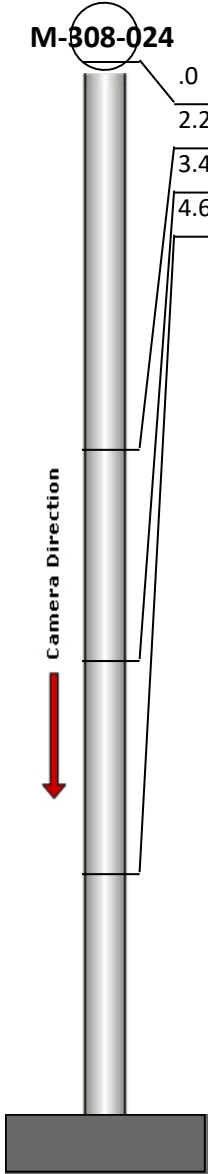
.0	MGP	General Photo	10	NA
	2.2	MGP	General Photo	28	NA
	3.4	DAZ	Deposits Attached Other	44	M 2
	4.6	MGO	General Observation	58	NA
