Manhole Inspection Report

Date:	03/26/2018	Weather:		Coding:	RZMACP
MH#:	M-308-026	Owner:	NA	Len. Surveyed:	9.1
P.O.#:		Surveyor:	John Kuglmaier	Rim to Invert:	9.6
Customer:		Cert. #:	U-1215-07002349	Wall Material:	Concrete (reinforced)

Street:	Colorado St. and Sapphire Ct.	Project:	Hobart, IN
City:	Hobart, IN	GPS Northing:	0.0
Location:		GPS Easting:	0.0
Drain Area:	Southwest	GPS Accuracy:	Nearest Meter
Cover Shape:	Circular	Evidence of Surcharge:	No
Cover Size:	22.5	Potential for Runoff:	None
Comments:

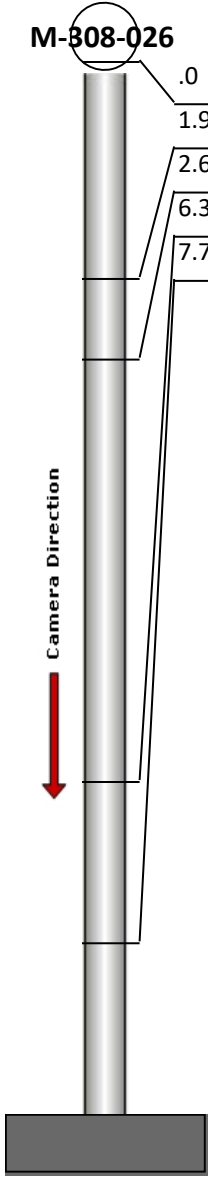
.0	MGP	General Photo	10	NA
	1.9	MGP	General Photo	28	NA
	2.6	IS	Infil Stain	43	NA
	6.3	DAZ	Deposits Attached Other	62	M 2
	7.7	MGO	General Observation	76	NA
