Manhole Inspection Report

Date:	04/13/2018	Weather:		Coding:	RZMACP
MH#:	M-403-001	Owner:	NA	Len. Surveyed:	7.7
P.O.#:		Surveyor:	John Kuglmaier	Rim to Invert:	8.7
Customer:		Cert. #:	U-1215-07002349	Wall Material:	Concrete (reinforced)

Street:	Gill St. 240' South of 38th Ave.	Project:	Hobart, IN
City:	Hobart, IN	GPS Northing:	0.0
Location:		GPS Easting:	0.0
Drain Area:	Northwest	GPS Accuracy:	Nearest Meter
Cover Shape:	Circular	Evidence of Surcharge:	No
Cover Size:	23.0	Potential for Runoff:	None
Comments:

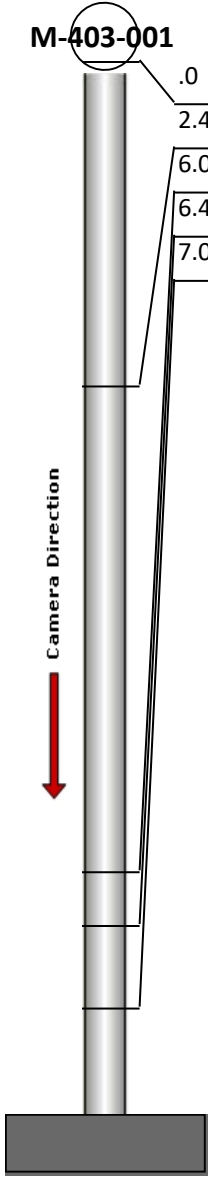
.0	MGP	General Photo	10	NA
	2.4	MGP	General Photo	29	NA
	6.0	DAZ	Deposits Attached Other	49	M 2
	6.4	IS	Infil Stain	62	NA
	7.0	MGO	General Observation	75	NA
