Manhole Inspection Report

Date:	05/14/2018	Weather:		Coding:	RZMACP
MH#:	M-404-026	Owner:	NA	Len. Surveyed:	5.9
P.O.#:		Surveyor:	Jen Costello	Rim to Invert:	6.5
Customer:		Cert. #:	U-907-5518	Wall Material:	Concrete (reinforced)

Street:	Dearborn St. 216' North of Ridge Rd.	Project:	Hobart, IN
City:	Hobart, IN	GPS Northing:	41.54201889
Location:		GPS Easting:	-87.28061676
Drain Area:	Northwest	GPS Accuracy:	Nearest Meter
Cover Shape:	Circular	Evidence of Surcharge:	No
Cover Size:	22.5	Potential for Runoff:	None
Comments:

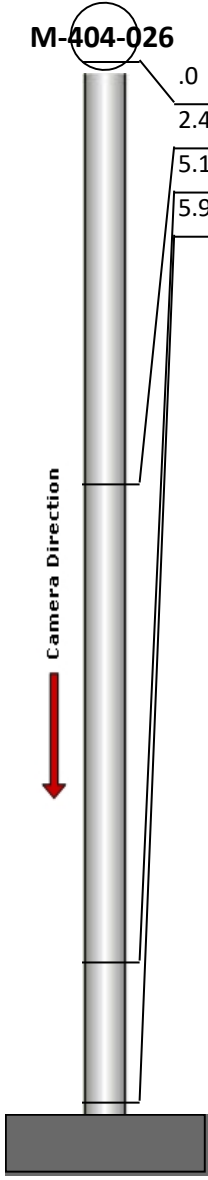
.0	MGO	General Observation	10	NA
	2.4	MGO	General Observation	28	NA
	5.1	OBR	Obstacle Rocks	47	M 2
	5.9	MGO	General Observation	61	NA
